Heritage Assessment

Dolman Residence – 1611 Cedar Crescent, Vancouver

October 2021

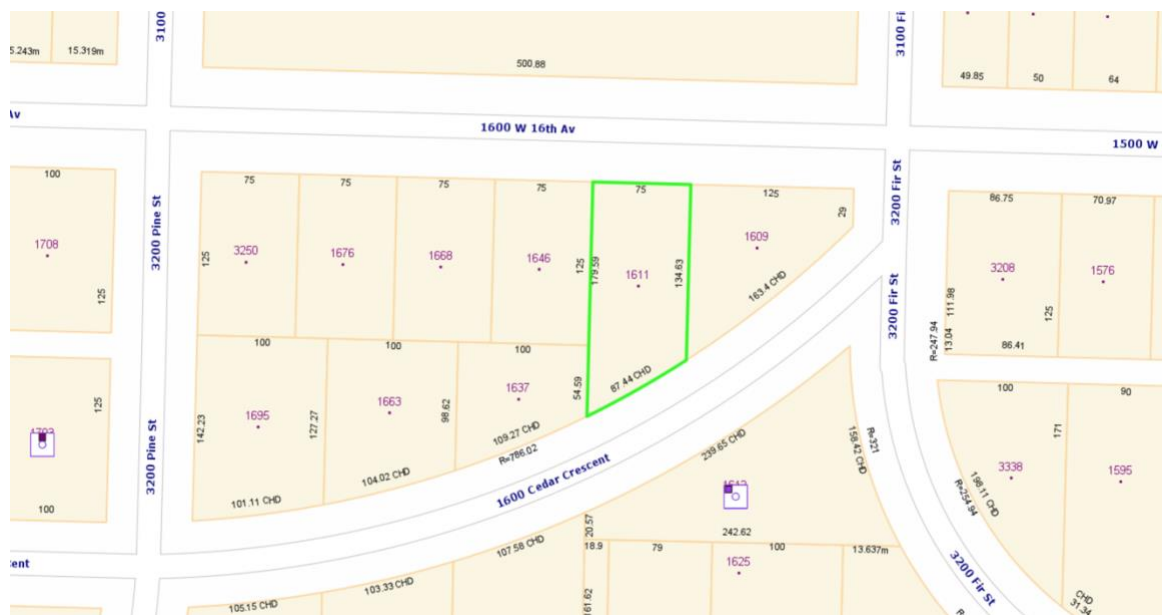
Figure 2: 1611 Cedar Crescent and its Surroundings – 1612 Cedar Crescent immediately to the south (VHR A-listing) and 1703 Cedar Crescent to the west (VHR B-listing). Source: City of Vancouver VanMap

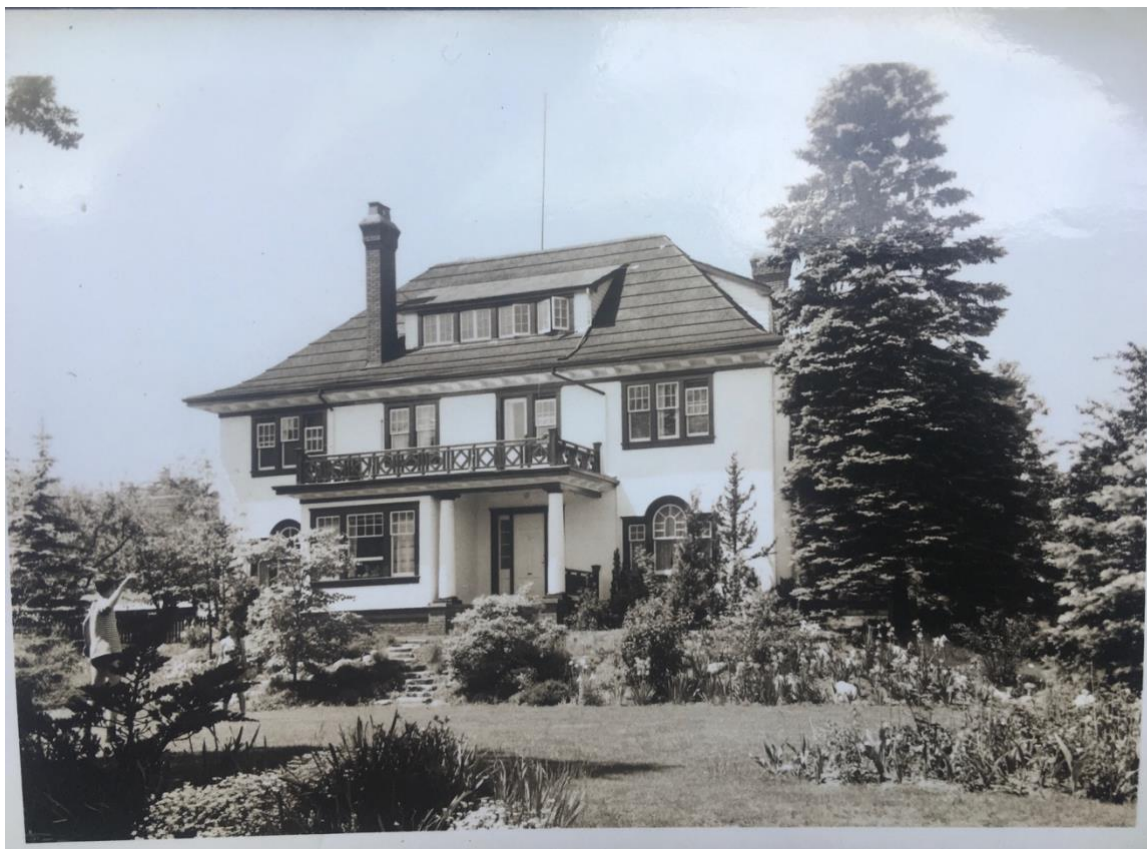
The true extent of the original paired lots, particularly the expansive front garden, is evident from a photo taken of the front of the house around 1949 (Figure 8). This shows how the house was strategically placed at the high point of the property, with the gently rising slope to the south-west. The route of Cedar Crescent followed those same contours, a common trait of the road layout in First Shaughnessy. The house is prominently displayed, as seen from the front garden. With very little rear yard, the expansive front yard gives the illusion of an even larger site, a design characteristic of many early properties in First Shaughnessy.

Figure 8: 1611 Cedar Crescent, seen from the north-east corner of the estate, c.1949. Source: Personal Collection of Jennifer Dolman.

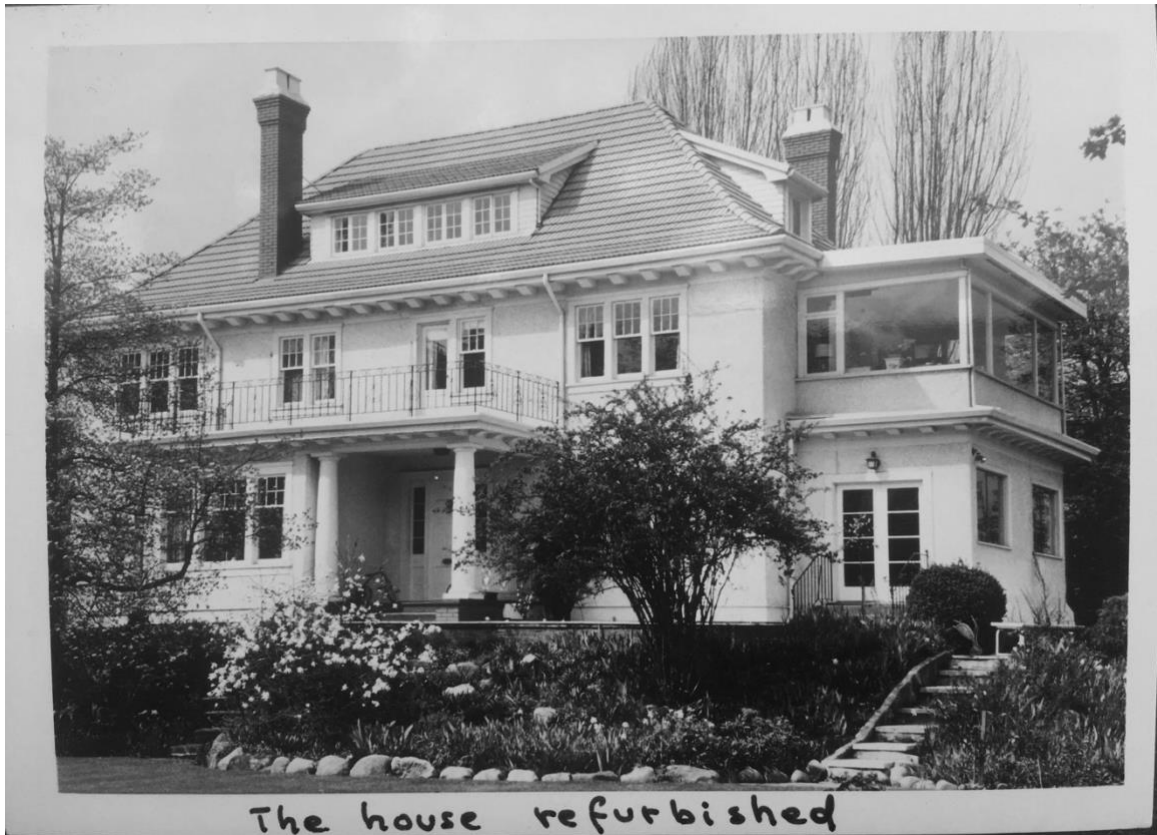
By the late 1960s, the Dolman Residence underwent minor alterations. This included the addition of an enclosed “sunroom” on the north side, above the main floor extension (Figure 9). This was to take advantage of the views of the city to the north, while its enclosure would likely have been for both weather protection and a buffer to the traffic noise along West 16th Avenue immediately to the north. The railing on the upper porch set above the front entry was also replaced with a wrought-iron railing. Otherwise, the house remained relatively intact through the latter half of the 20th century.

Figure 9: 1611 Cedar Crescent, seen from the north-east corner of the estate, c.1969. Source: Personal Collection of Jennifer Dolman.

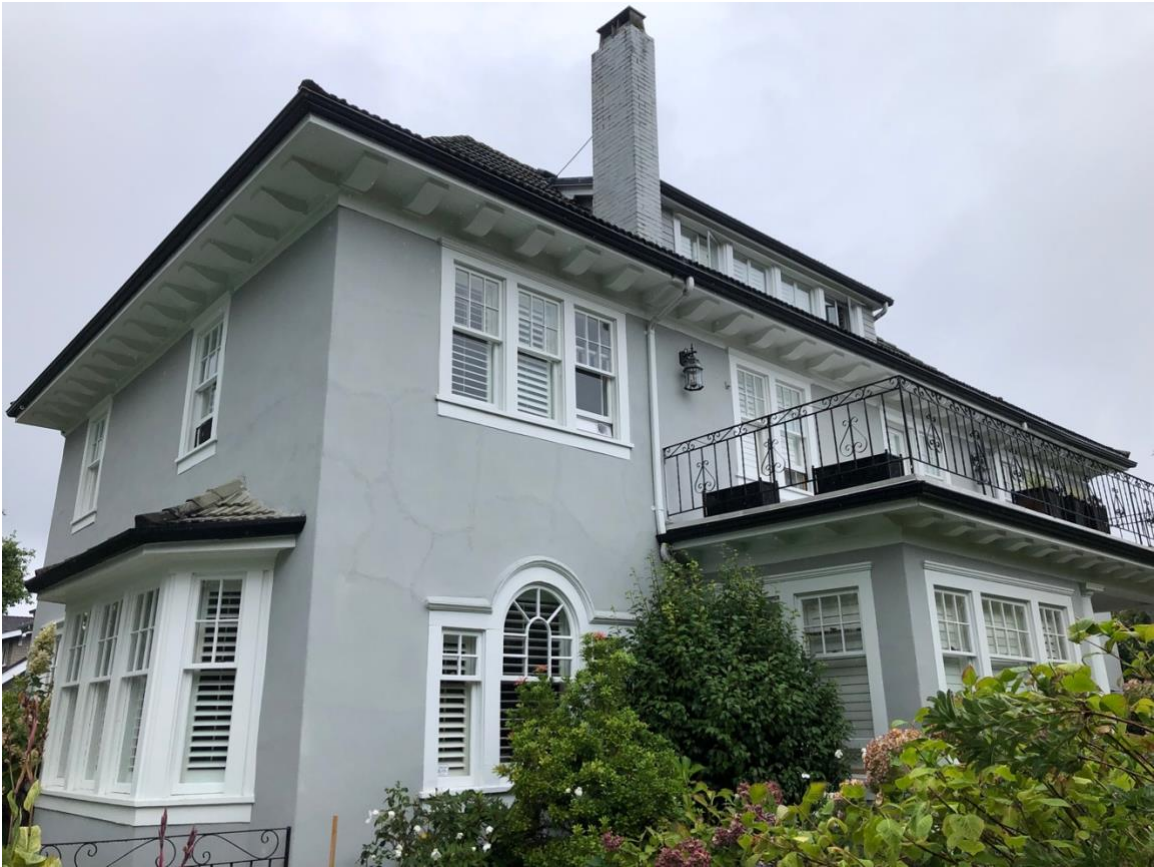
Figure 10a: East side – Front entry not visible, see photo below

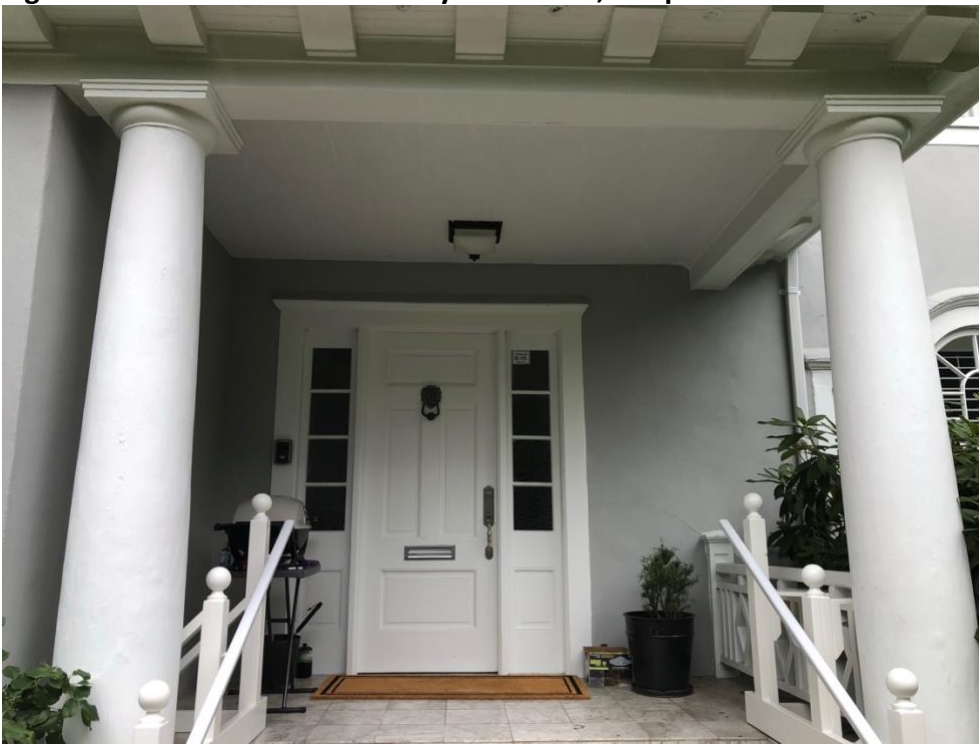
Figure 10b: Entry porch with columns, door and sidelights

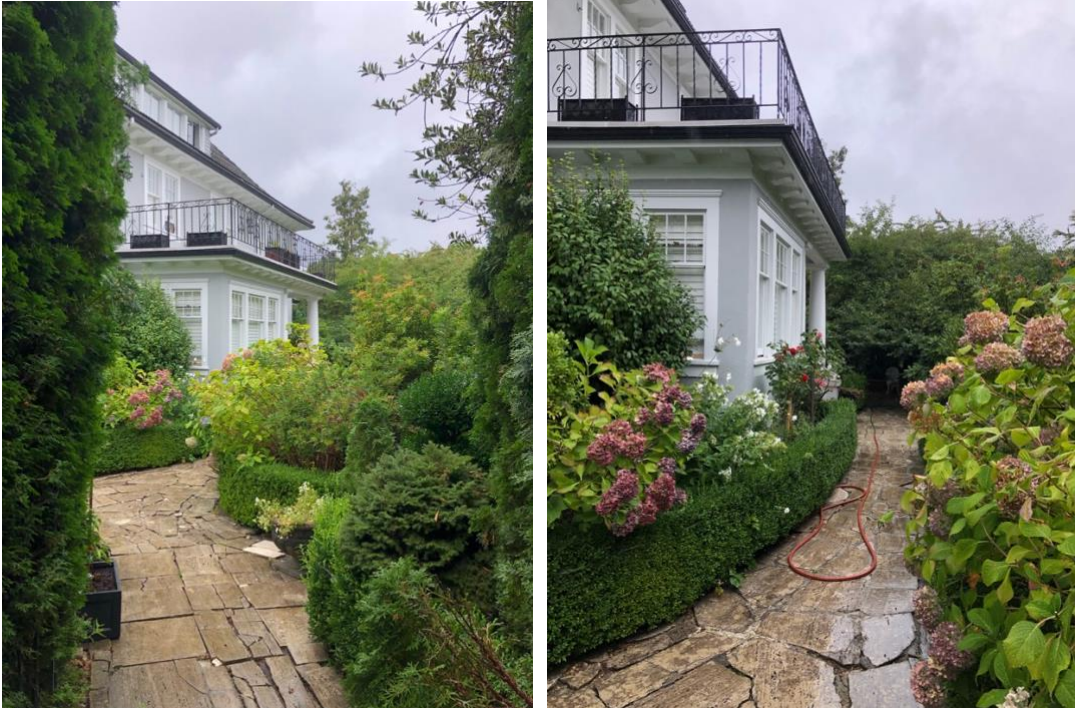
The front of the house is accessed by a narrow walkway from Cedar Crescent framed by hedging and plantings. The walkway opens up adjacent the pool and continues to the front porch (Figure 23).

Figure 23: Walkway into property from Cedar Crescent (above) leading to main entry porch (below)

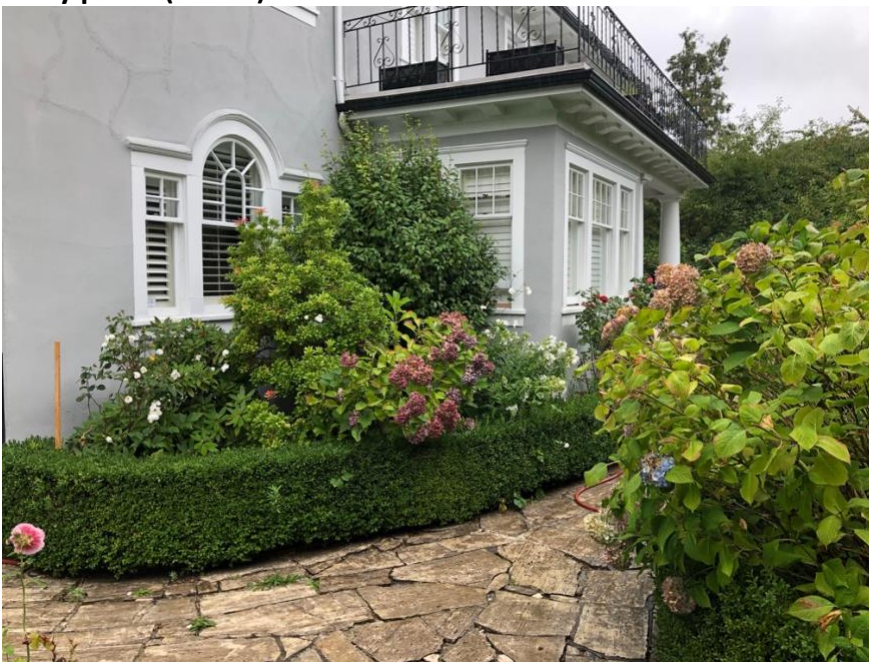
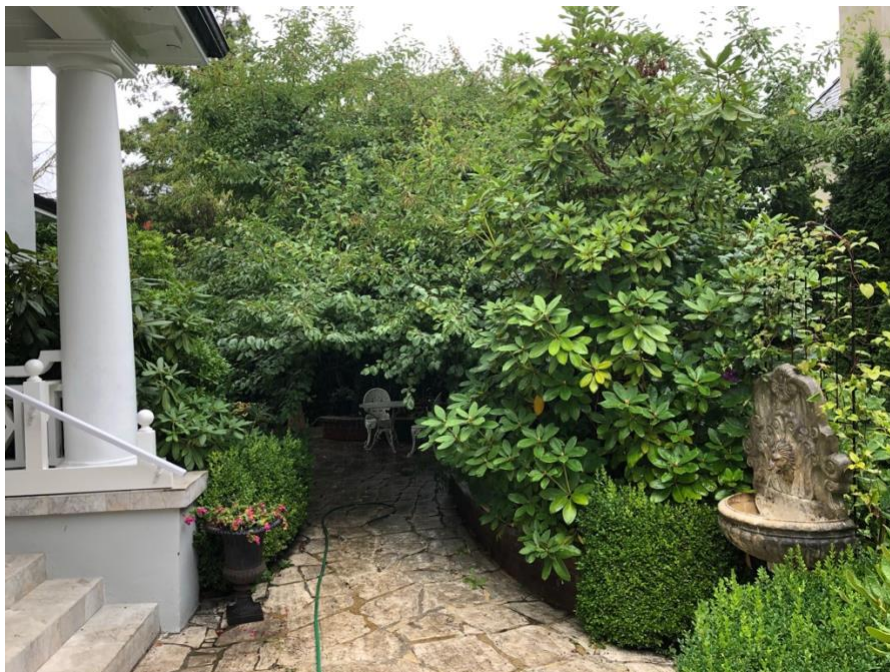
Figure 23: Entry porch (left) and passage to north side of property

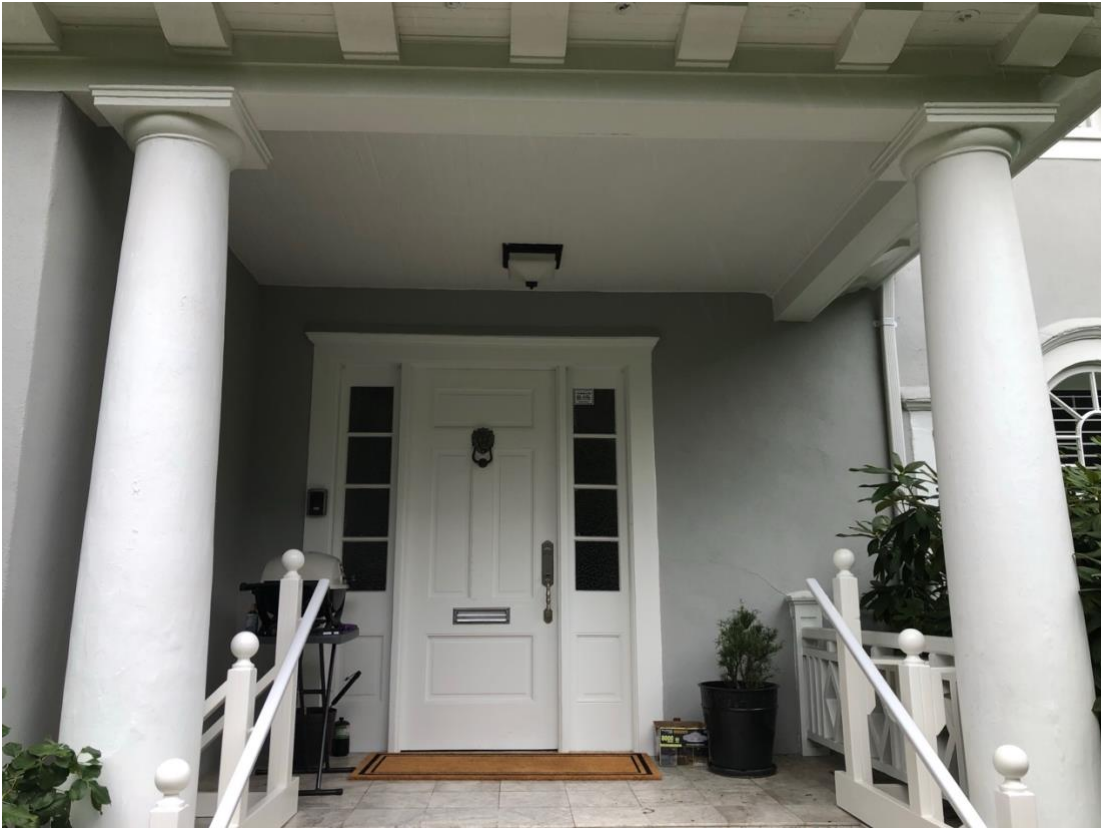
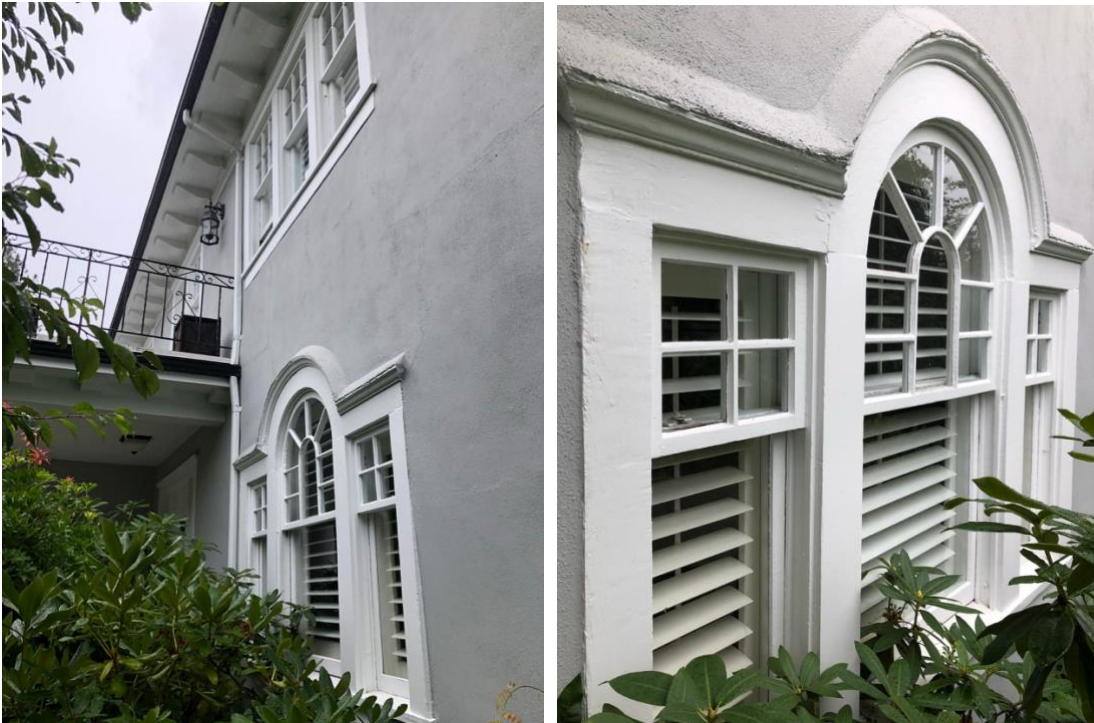
The front of the house is defined by a modest covered porch, enclosed on the south side by the front room extension, and open on the north side (Figure 24). The entry door is flanked by sidelights and the north side of the porch has an original balustrade. The front of the stairs is framed by a pair of Tuscan columns.

Figure 24: Front porch, columns and soffits; details of front windows (below)

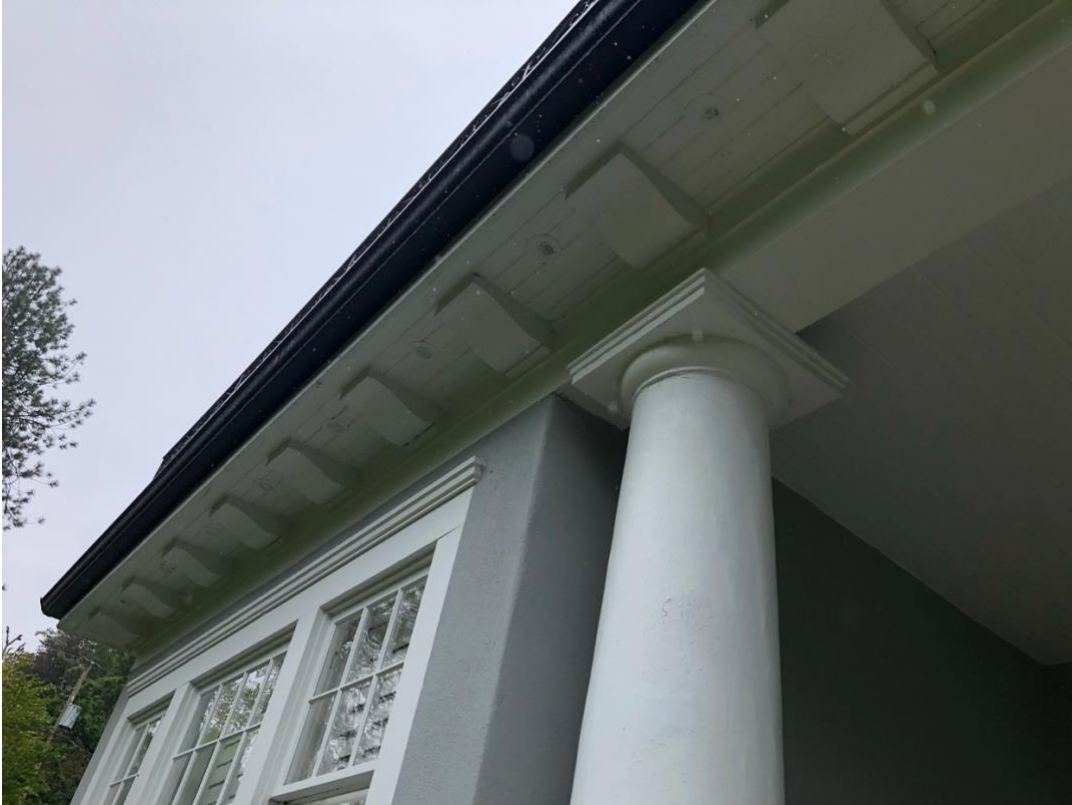
Curved brackets frame the roof overhang of both the porch and the main body of the house (Figure 25).

Figure 25: Detail of curved brackets in soffit

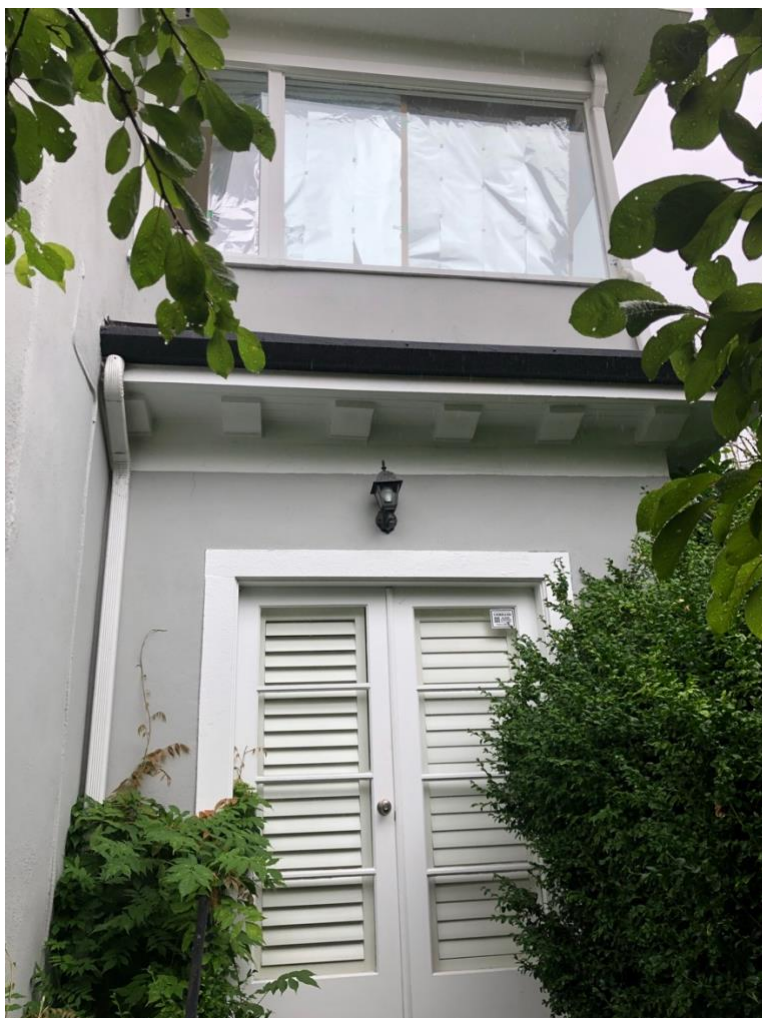
The north section of the main floor of the house features a library extension. This was originally a single floor, and an enclosed sunroom was added on top at a later date (Figure 26).

Figure 26: Paired doors accessing the library at the north end of the east side (front)

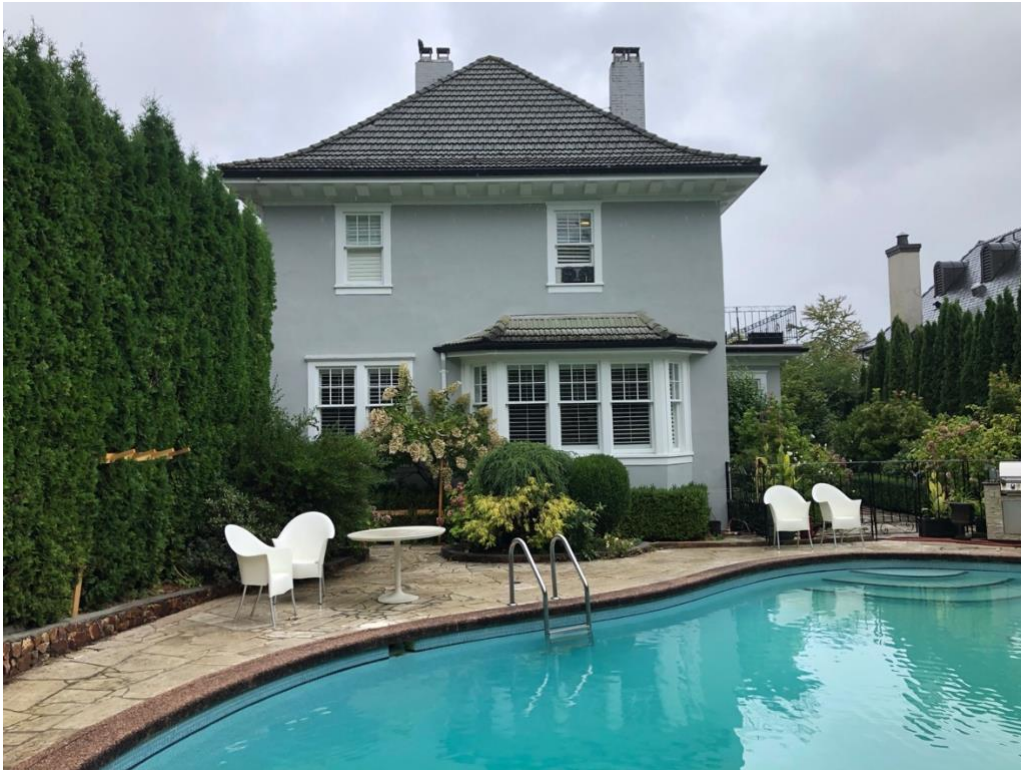
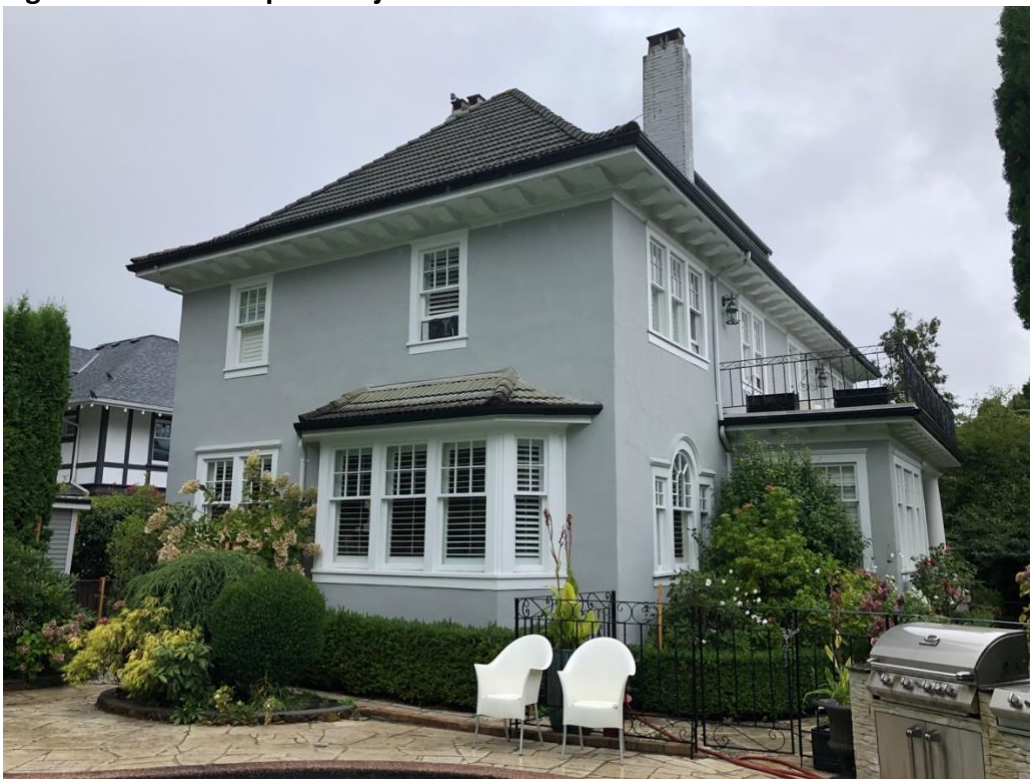
The south side faces on to an enclosed patio and pool, and this section of the yard is well defined by tall hedges (Figure 27). A wide angled bay window of the dining room is the feature on this side of the house. Adjacent to the bay is a pair of windows and on the second floor there are two single windows. The pool was installed c. 1971 and replaced a small orchard.

Figure 27: Pool and patio adjacent the south side

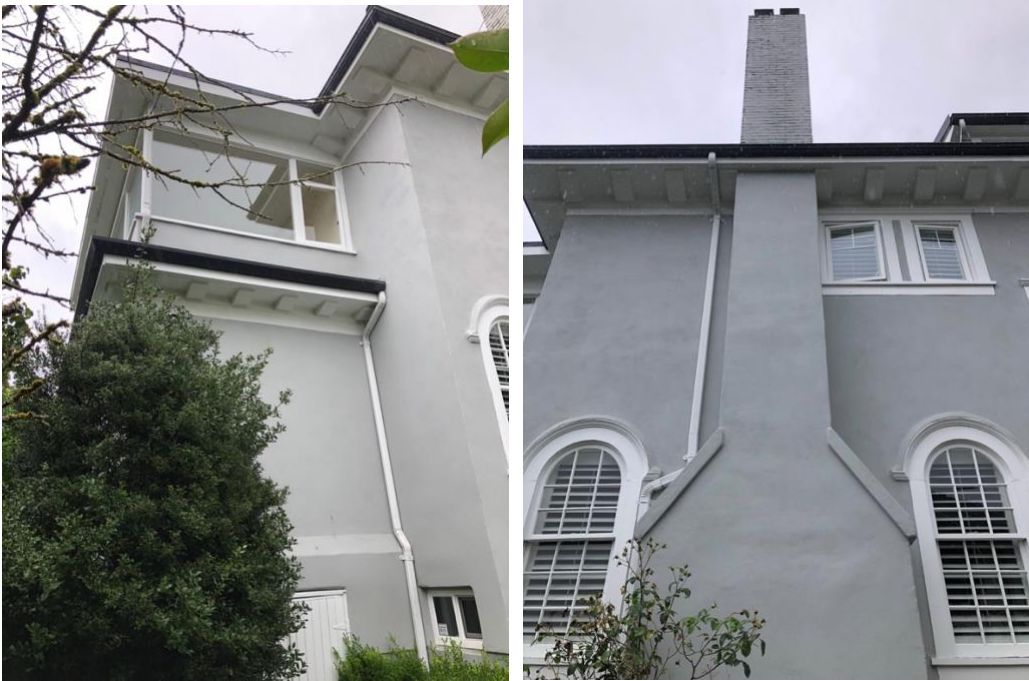
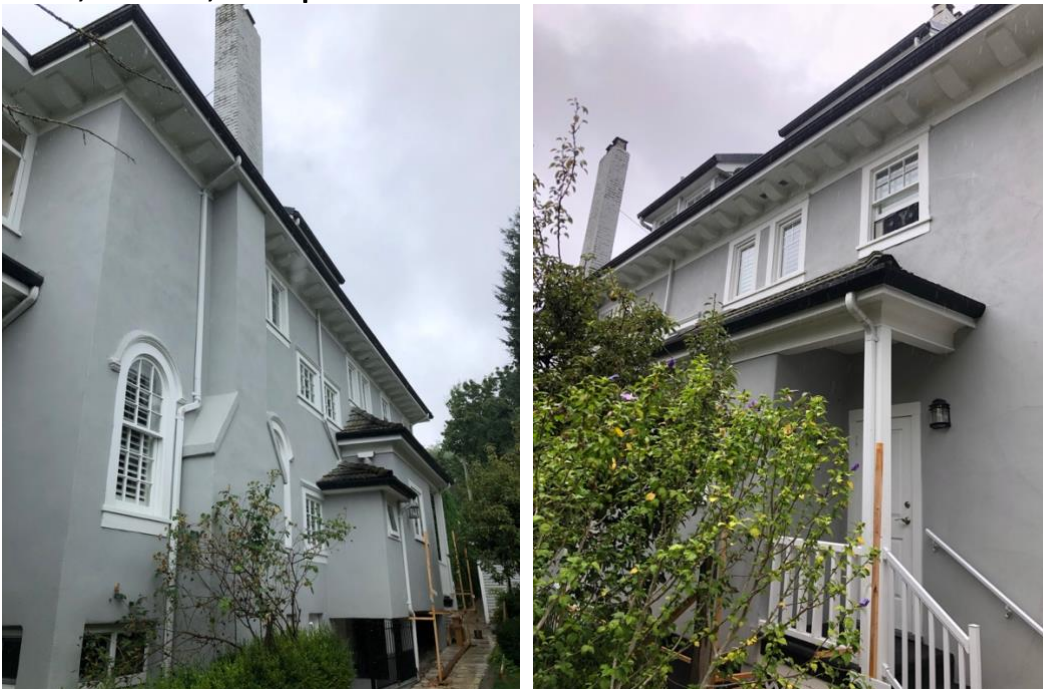
The west side of the house is less decorated than the front or south sides, but it has several features of note (Figure 28). The primary chimney is set on this wall, with single windows on either side featuring the rounded top sash with the slender raised stucco lintel spanning the top.

Figure 28: West side, clockwise: Sunroom extension, north end; Chimney and window detail; full view; small porch with access to the rear

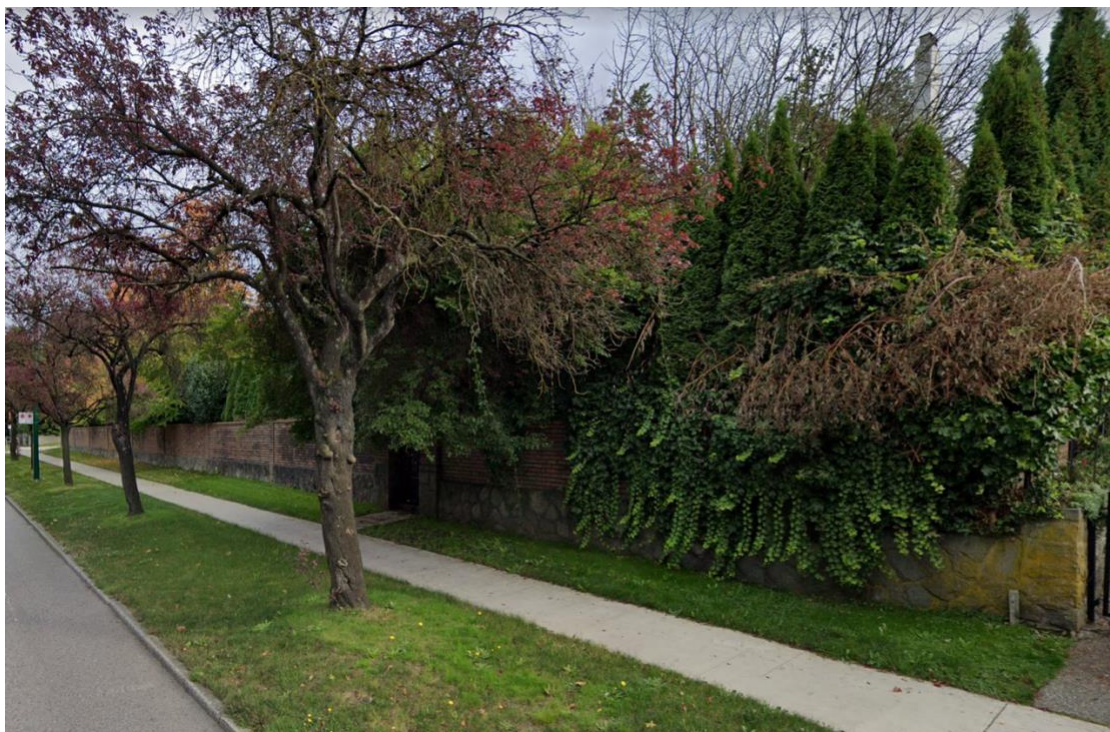
As a result of the abundant vegetation set between the house and West 16th Avenue, the house is not visible on the north side (Figure 29). The library has two pairs of plain windows, while the sunroom above has a full span of windows. There is a long brick and stone-base perimeter wall running along this side which illustrates the original size of the estate.

Figure 29: Frontage of property along West 16th Avenue

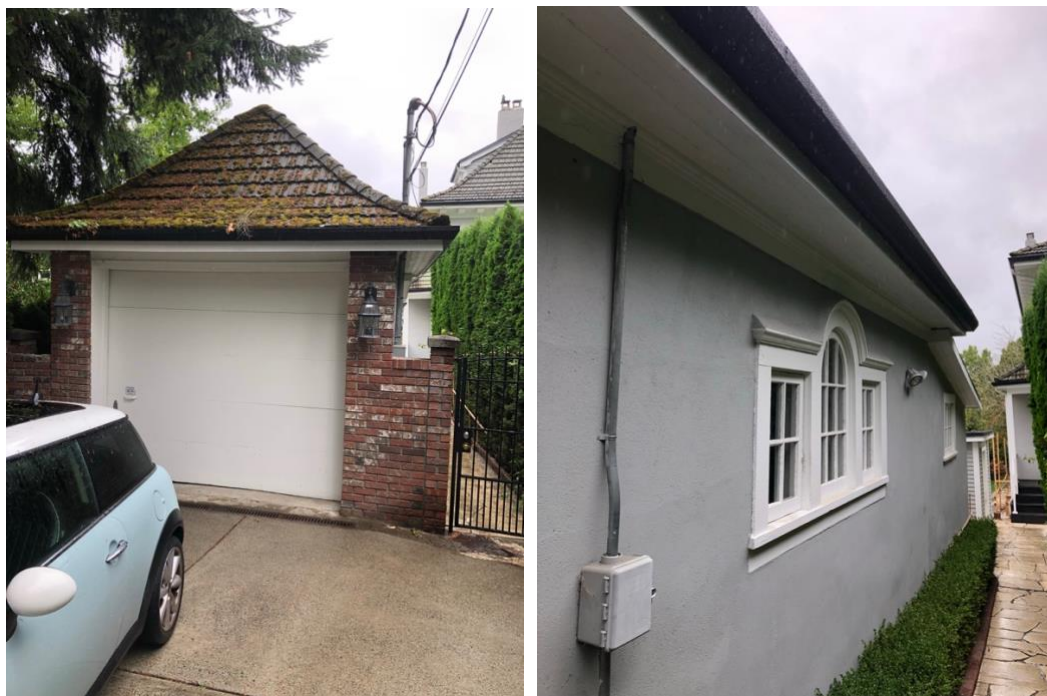
The single-car garage is accessed from Cedar Crescent and retains its original siting. Although the garage door and its surrounds are newer, its sides and rear feature original windows and cladding (Figure 30).

Figure 30: Garage accessed from Cedar Crescent; East side wall

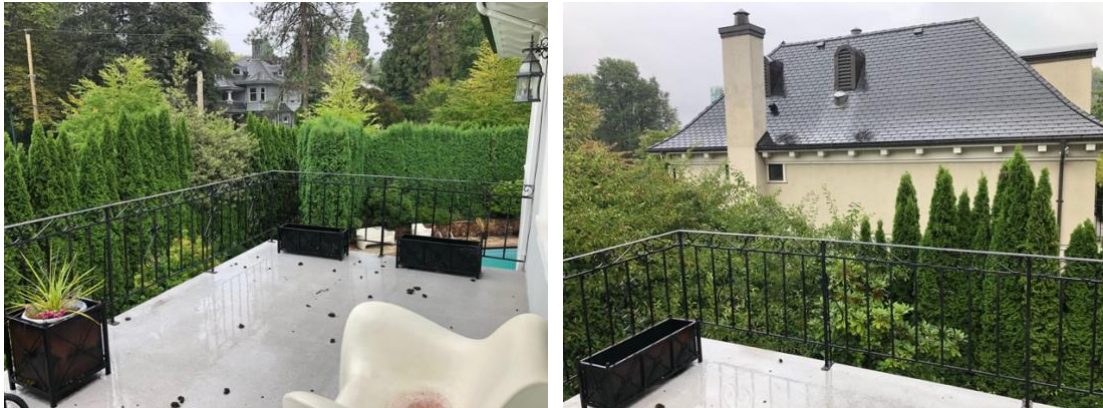
The wrought iron railing surrounding the front porch, set above the main entry, is a more recent alteration (Figure 31). It would have replaced an earlier (and likely original) railing surround, likely made of wood in a style similar to that of the front porch balustrade. This railing is out of form with the rest of the house and cannot be considered a character defining element.

Figure 31: Wrought iron upper front porch railing, looking south-east and east

- The railing above the front porch may require replacement due to its condition or required VBBL upgrades (or both). In that case, it can be either a style to match the existing – which has been in place since the late 1960s and in itself has become a character defining element – or a restoration of the original design and material (i.e. wood). **[Note: Final decision rests with the City of Vancouver Planning staff.]**

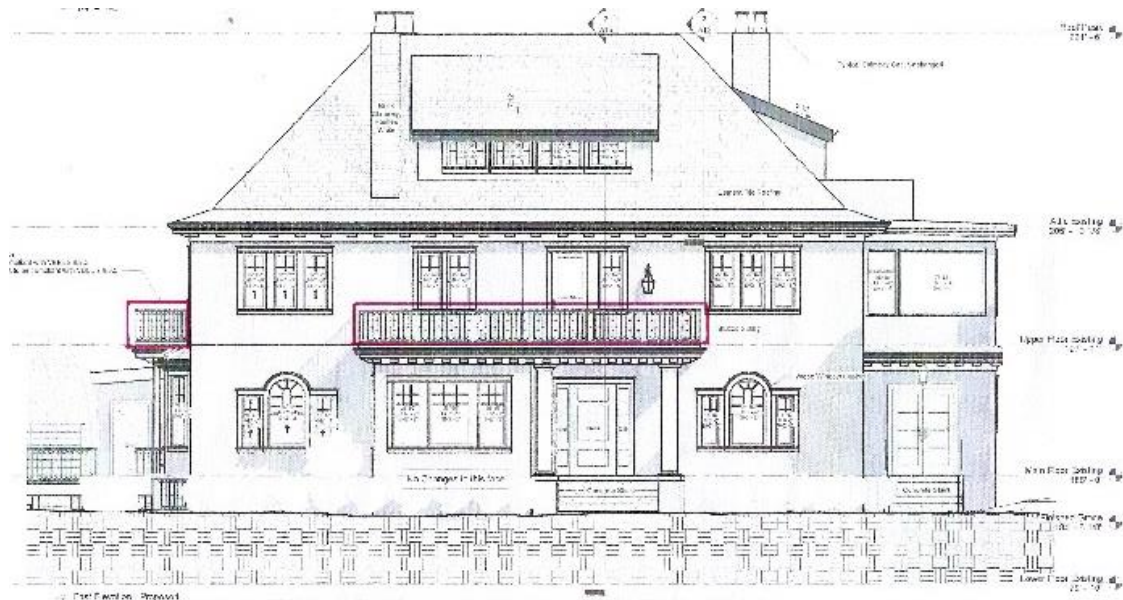
Figure 32: Proposed East Elevation

The east elevation of the Dolman Residence is proposed to undergo rehabilitation of the wrought iron railing situated above the front porch (Figure 32). The archival images obtained as part of this Heritage Assessment should serve as the guide to a historically-appropriate restoration of either the original railing, or the one that has been in place since the late 1960s (see archival images, pages 9 and 10). Either option fulfills the principles of *Standards and Guidelines for the Conservation of Historic Places*. The more historically-accurate option, though, is a wood railing restored to original (pre-1960s) design; the decision on which option is more appropriate in the context of the *First Shaughnessy HCA Design Guidelines* rests with City of Vancouver Planning staff.

In the case of a restored wood railing, the height is expected to be an issue, since the original railing was quite low. Therefore, in order to meet the requirements of the Vancouver Building By-law, a slender top railing (typically steel) may be added to the top of the traditional-height balustrade, with glazing set in between to make it as transparent and unobtrusive as possible.

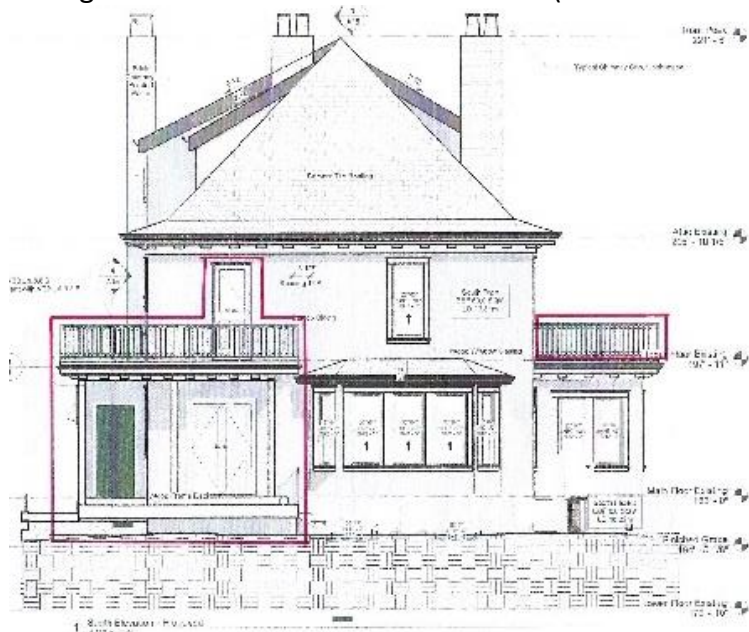
Figure 33: Proposed South Elevation

The south elevation of the Dolman Residence is proposed to undergo rehabilitation on the main floor and second floor (Figure 33). The work is limited to the rear corner, with a set of paired doors replacing the paired windows on the main floor, allowing access to the expanded wrap-around porch, and a single door in place of the existing double-hung window to access a wrap-around upper porch of roughly the same proportions. The openings will not be widened – the existing width will be maintained. The porch railing should be designed to be compatible yet distinguishable from the one on the front (see section 5.5).

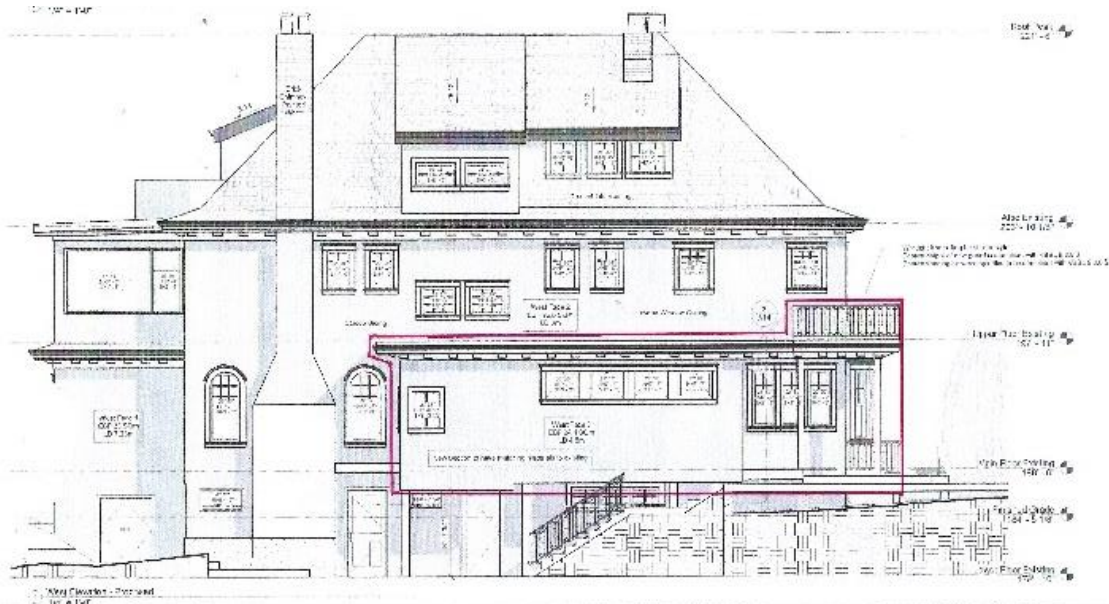
Figure 34: Proposed West Elevation

The west elevation of the Dolman Residence is proposed to undergo the most extensive rehabilitation, consisting of an extension to the kitchen on the main floor (Figure 34). The form of the extension is proposed to be presented as a flat roof. While this is not typical of Shaughnessy roof forms, the rationale for this is to minimize the extent of the west wall that will be either altered: a sloped roof would cover up a larger percentage of the west wall and negatively affect several existing windows. The flat roof is proposed to have a soffit that is similar to the others on the house, with decorative brackets. Cladding will match the rest of the house and the high-set kitchen windows will be wood frame and sash.

It is also important to note that this work is on the side of the house that cannot be seen from any vantage point, either from the street, or on the property itself with the exception of the narrow west (rear) yard. Its impact on the heritage character of the house is minimal.
